Investigation into the remediation of the contaminated site at Mapua

Water quality technical annex

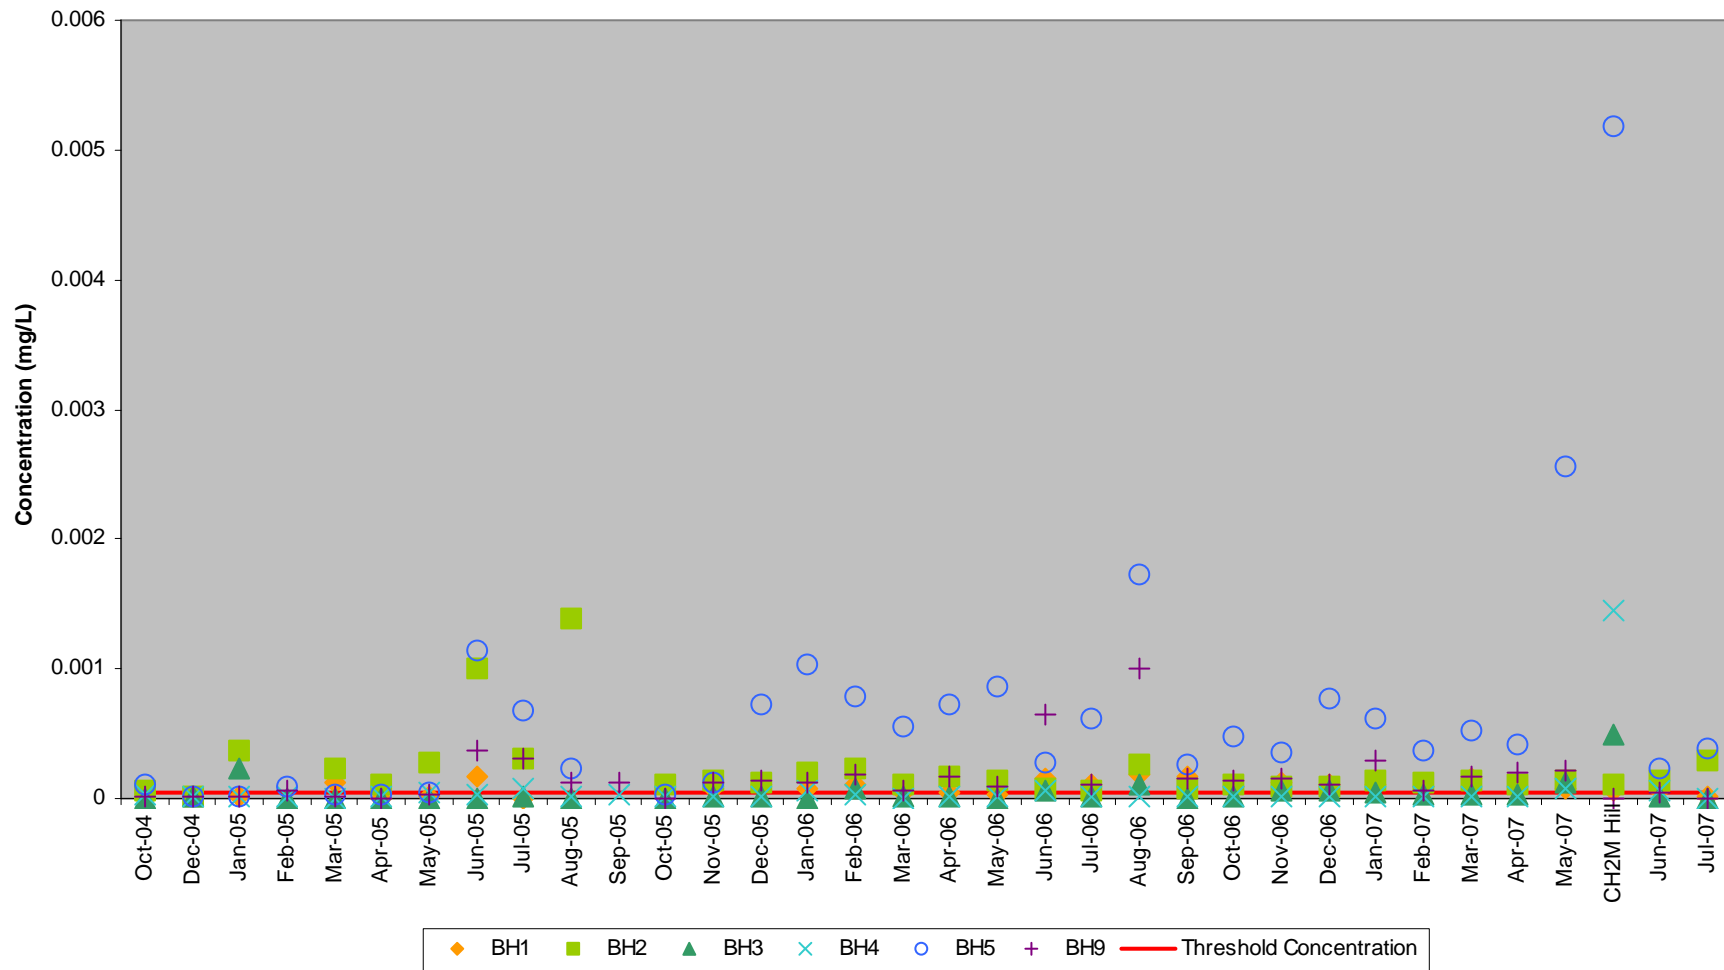
Figure 1: DDT concentrations in site monitoring wells

[Figures 1](#) and [3](#) show a distinct increase in DDT and lindane results from June 2005 onwards. This coincides with the change in sampling protocol, but monitoring reports from the sampling contractor, ChemSearch, show that samples for pesticide analysis were centrifuged both before and after June 2005. The CH2M Hill (2007) report states that their pesticide samples were decanted, which may account for the high DDT concentrations seen during their investigation, particularly in BH5. (The site auditor had recommended that CH2M Hill filter samples for pesticide analysis.)

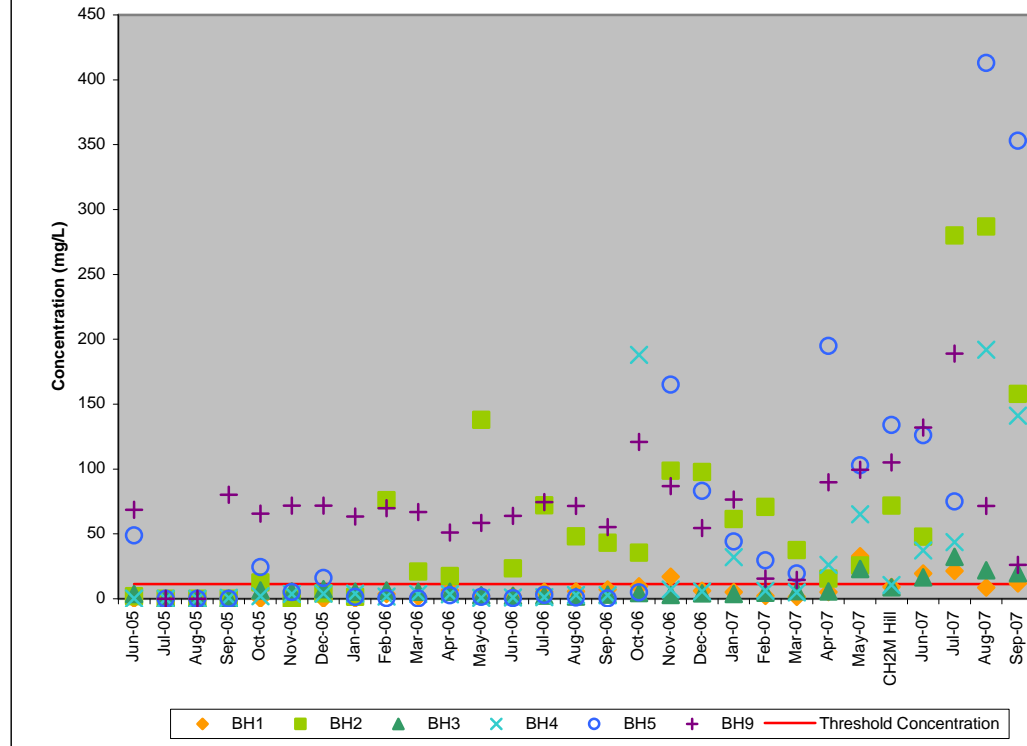
Figure 4: Nitrate concentrations in site monitoring wells

[Figures 4 and 5](#) show that nitrate concentrations at the southern site monitoring wells BH2, BH5 and BH9, and the residential bore at 26 Tahi St, have generally been well above the threshold concentration. From early 2007, nitrate began to exceed criteria at BH1, BH3 and BH4, and then at 13 Tahi St as well.

The distribution of elevated nutrients is not quite as expected in the AEE or the PDP (2007) groundwater issues report. It was expected that nutrients would be detected principally in monitoring wells BH1 and BH2 on the FCC East area where the majority of nutrient-containing treated fines were deposited (refer the Soil Technical Annex). [Figures 4 and 6](#) show that nitrate and $\text{NH}_4\text{-N}$ are indeed elevated at BH1 and BH2, and also at BH4 and BH5 in the Landfill Area where some treated fines were placed. But nitrate is elevated at BH9 on the southern boundary of the FCC West Area, and further south of FCC West at 26 Tahi St, which cannot be explained by reference to backfilled treated fines.
