Investigation into the remediation of the contaminated site at Mapua

July 2008

Parliamentary Commissioner
for the **Environment**

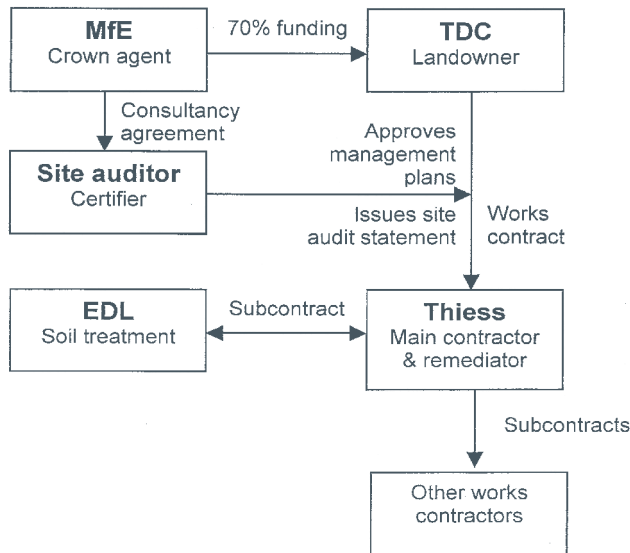
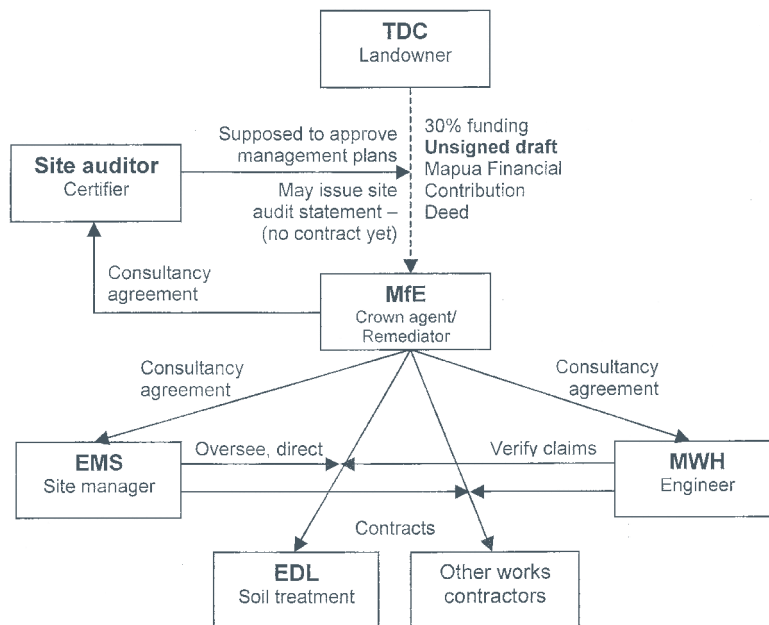
Figure 4: Project management structures for Mapua remediation works

Original structure January 2004

After Thies withdrawal September 2004

The changing roles of the various parties are outlined in Figure 4, which shows that MfE’s decision to take over Thies’s role had major implications for project management.
